## Oblast Konin

### Konin area

In Poland only one opencast lignite mining company have experience in creating pit lakes, KWB Konin in central Poland. Other lignite mining companies are currently exploiting their deposits and plan to create pit lakes in final pits. In the Konin Basin exploitation of lignite started in the 1940s. Up to the date seven final pits have been completed and flooded, two are during flooding and three more are planned to be flooded after completion of lignite excavation. Short description of all present pit lakes in the Konin area and their usefulness for the RAFF project is presented below.

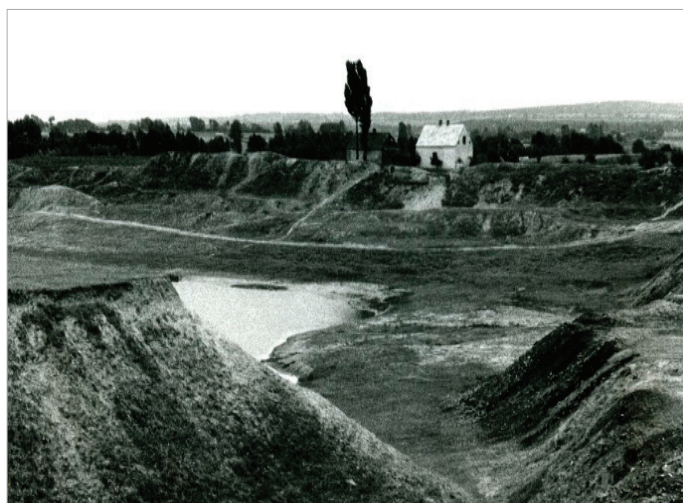
Fig. 1: Morzysław open-pit during lignite exploitation (KWB Konin).

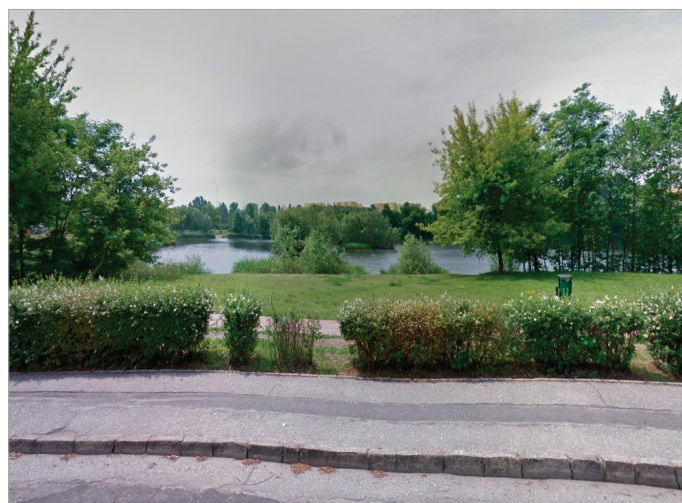
Fig. 2: Flooded Morzysław pit.

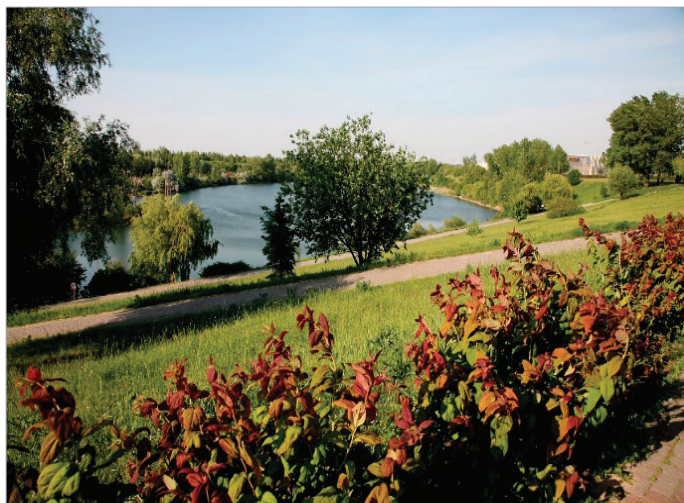
Fig. 5: Flooded Niesłusz open-pit.

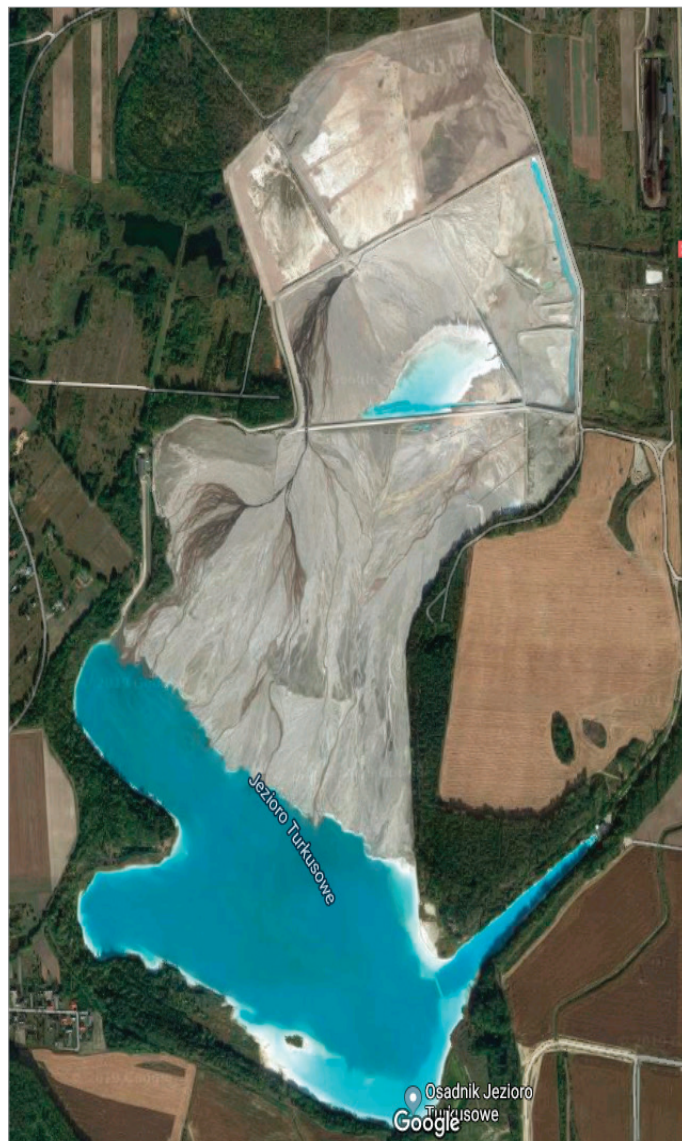
Fig. 6: Gosławice pit lake partially filled with industrial wastes (Google Maps).

In one final pit, the Czarna Woda Lake with an area of 32.5 ha was created. The area around the reservoir was aligned and planted with trees and bushes. The reservoir and its surroundings are a popular recreational place for the inhabitants of Konin city. Next to the Czarna Woda lake there is also a smaller reservoir (3.8 ha), created in a place of the industrial water settler from the briquetting plant. In the final pit in the north part of Gosławice field storage of industrial wastes was created. These wastes were collected from aluminium smelter (aluminium oxides) and neighbouring Pątnów power plant (furnace ashes). This lake is forbidden to swim and other non-industrial activities. The deposition of industrial wastes in this pit lake exclude it from later stages of the RAFF project.

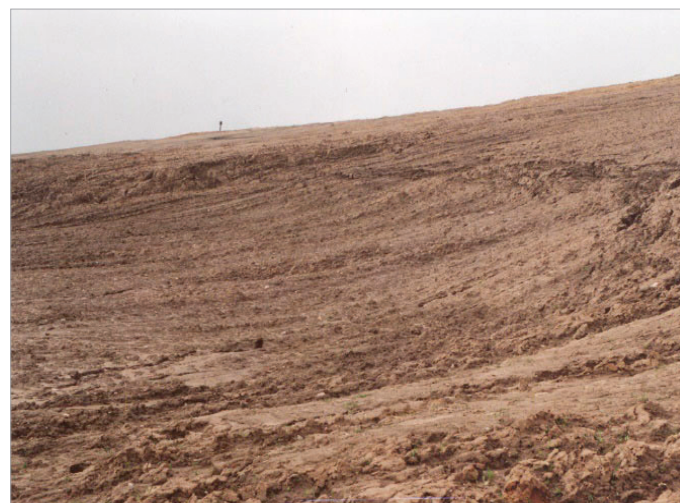
Fig. 7: Lowering of the slope surface (Bajcar 2007).

The next stage of slope degradation was the dislocation of the slope fragment towards the excavation (Fig. 7) continued by landslides resulting from the outflow of material into a landslide covering the entire eastern slope region of the Pątnów final pit (Fig. 9).

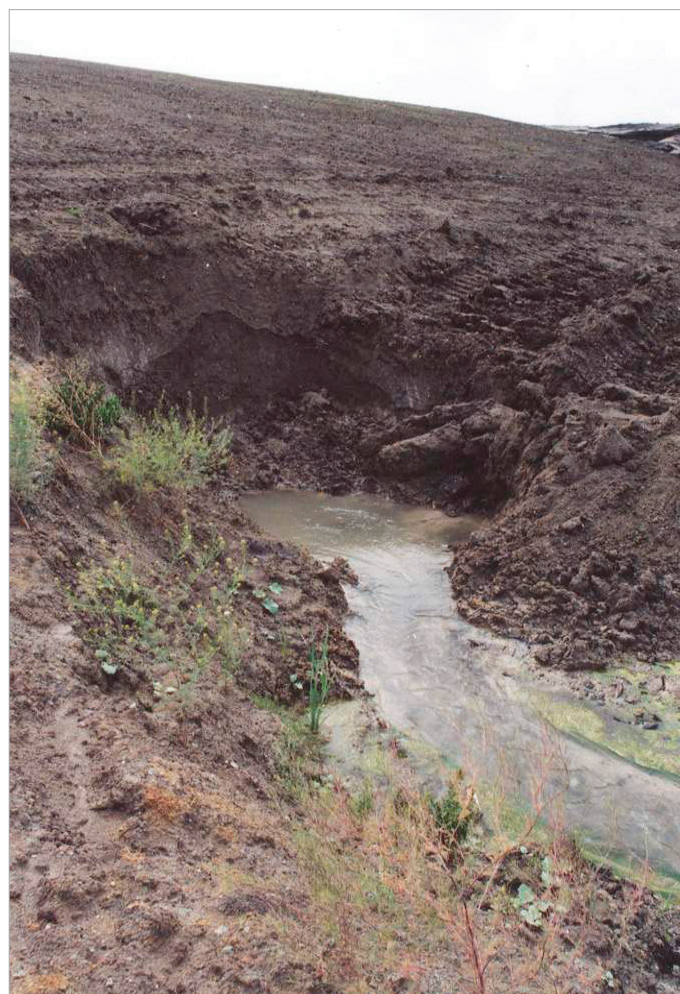
Fig. 8: Watercourse at the intersection of the slope plane with the erosion trough (Bajcar 2007).

The first signal of a global change in the stability conditions of the slope was a surface lowering due to the subsidence of the

layers in places from which the material was previously removed by the water flowing into the final pit (Fig. 8).

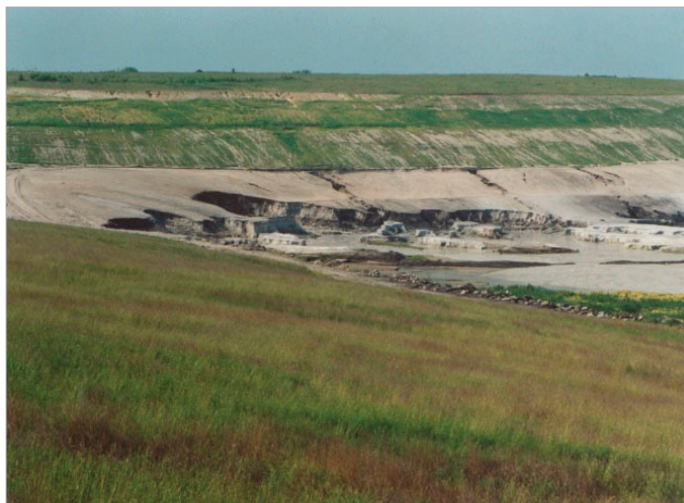
Fig. 9: General view of the landslide (Bajcar ,2007).

of the final slope of the „Pątnów” open-pit was initiated by local suffusion-erosive washings. The landslide developed after cessation of drainage of the section where the final slope crossed the unrecognized extensive erosion trough. After limiting the deep drainage, concentrated outflows appeared on the slope in the eastern and western parts of the section corresponding to the erosion troughs. On the eastern slope they led to the creation of a landslide threatening the areas adjacent to the excavation.

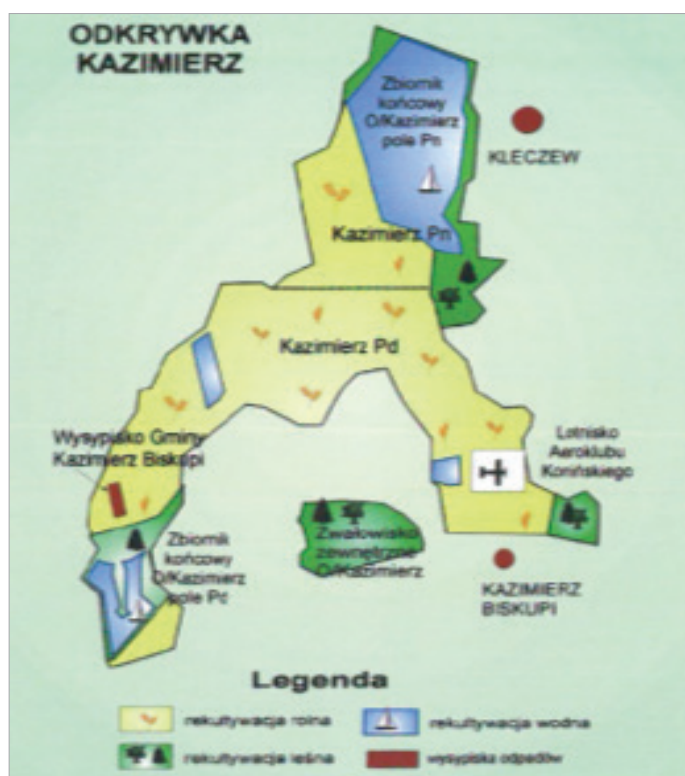
Fig. 10: Reclaimed area of the Kazimierz open-pit. (Kasztelewicz, 2010)

The reclaimed area of Kazimierz Południe pit occupies 110 ha. A water reservoir of 65 ha was created there, divided into two parts, whose slopes were reinforced with geotextile and geogrid. In the area of the reclaimed internal dump there is the airfield of Konin Aero Club. According to the land development plan, in the area of the Kazimierz Północ open-pit, a 520 ha water reservoir will be created in its final pit.

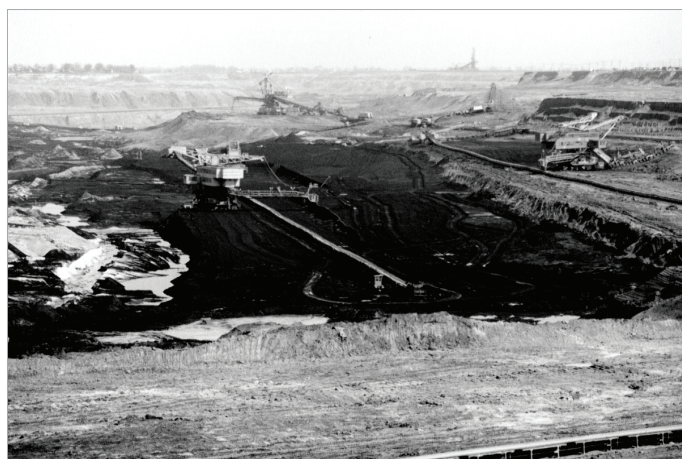
Fig. 11: The Józwin open-pit during mining operations (KWB Konin).

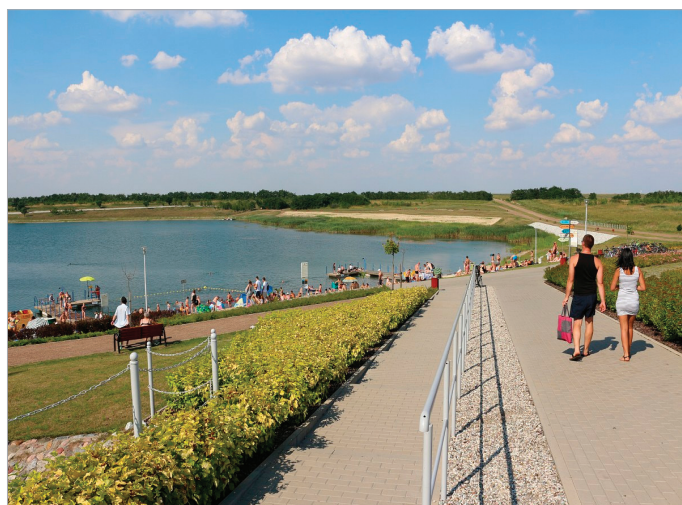
Fig. 12: Reclaimed area of the Józwin open-pit (Recreation and Physical Activity Park) (KWB Konin).

The area of the Józwin II A open-pit was reclaimed in the recreation and sports direction - with use of the EU funds a Recreation and Physical Activity Park was created there. The recreational complex, called by miners „Malta Bis” includes a water reservoir with a beach, floating platforms, a water equipment rental store, an amphitheatre and numerous walking and cycling paths, a rope park, quad bike routes, a children's playground, a sandy playground and a grill hut. The „Kleczewska Malta” Hostel with 25 beds has been opened in the former dispatch building nearby.
