## Jezero Medard

### Lake Medard

Lake Medard is located in the area of the former open-pit mine Medard-Libík. Flooding from Ohře river started in October 2011 and finished in January 2016. Lake Medard is as far the largest lake in the Czech Republic with surface area of 495 ha and water volume of 119 mil. m<sup>3</sup>.

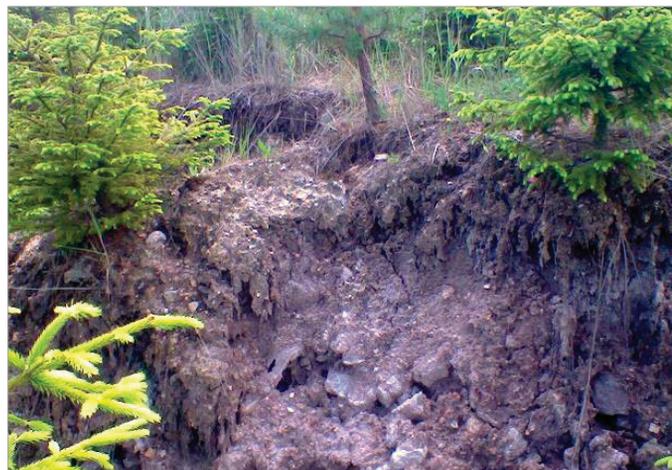
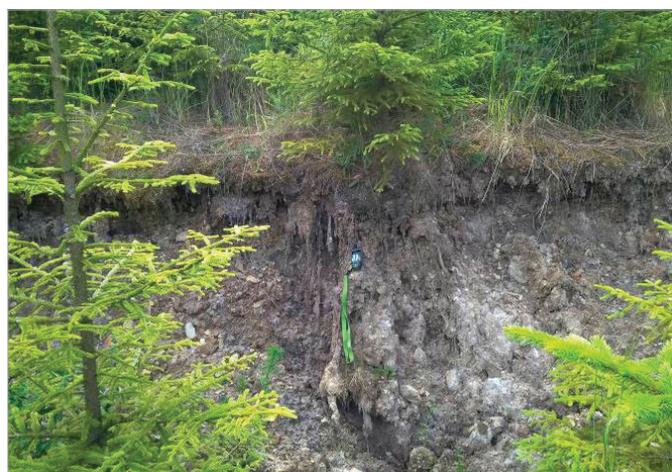
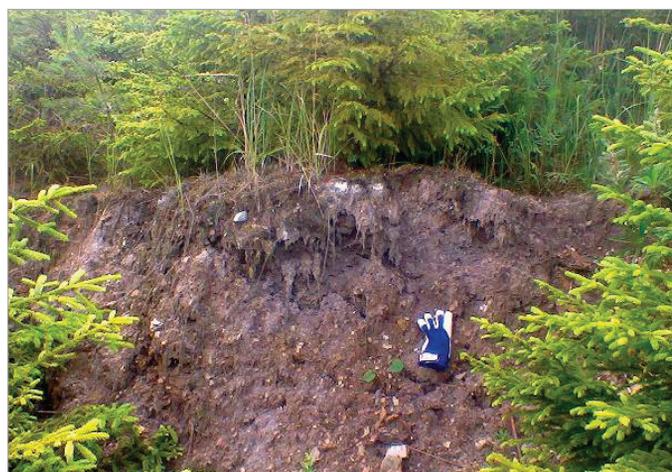
Fig. 10: Tension crack on the southern slope of Lake Medard below the village of Bukovany in 2017.

Fig. 11: Tension crack on the southern slope of Lake Medard below the village of Bukovany in 2018.

Fig. 12: Tension crack on the southern slope of Lake Medard below the village of Bukovany in 2019.

On the southern slope of Lake Medard below the village of Bukovany, above the area of geodetic points B6 and B11, where creeping horizontal movements are observed, the observed

tension crack is visually monitored within the monitoring. The crack length is approx. 76 m. Even after 2019, the crack does not increase significantly after visual inspection. The outflow of groundwater is observed in the western part of the crack and even in the dry season, this part of the slope is considerably saturated by groundwater. In the vicinity of the crack the planted forest stands grow and this area becomes less and less accessible. To compare the situation, photos from the years 2017, 2018 and 2019 are shown here (Figs. 10 - 12).

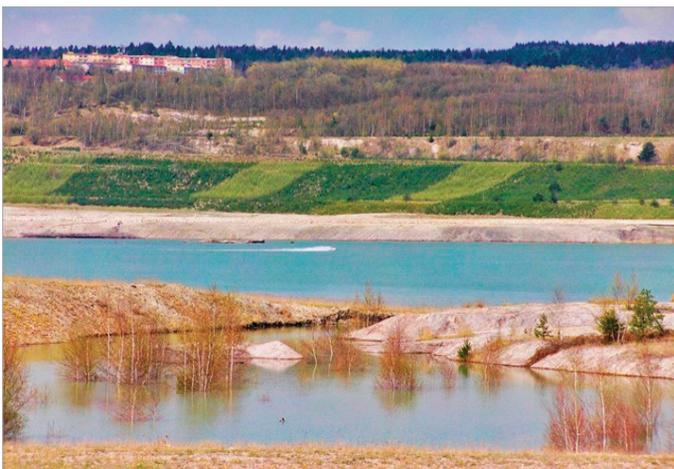
Fig. 13: Redeveloped and reclaimed northern slopes of Lake Medard (Photo: P. Valvoda, 04/2014).

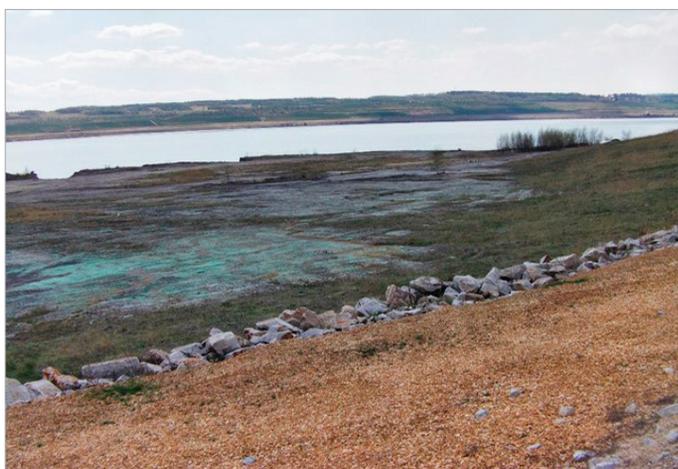
Fig. 14: Shore line with anti-abrasive system (Photo: P. Valvoda, 04/2013).
